BOILER TUBE ANALYSIS

**BY
S.V RAJU**

AT ASSALAYA —SUDAN

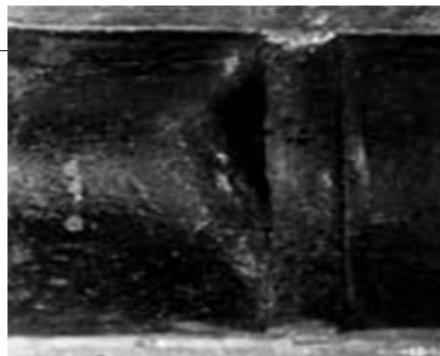
1.Caustic Attack .

Symptoms: Localized wall loss on the inside diameter (ID) surface of the tube, resulting in increased stress and strain in the tube wall.

Causes: Caustic attack occurs when there is excessive deposition on ID tube surfaces. This leads to diminished cooling water flow in contact with the tube, which in turn causes local under-deposit boiling and concentration of boiler water chemicals. If combined with boiler water chemistry upsets of high pH, it results in a caustic condition which ***corrosively attacks and breaks down protective magnetite***

CAUSTIC ATTACK

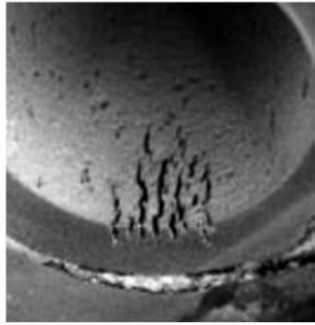
6. Waterside Corrosion Fatigue

Symptoms: ID initiated, wide transgranular cracks which typically occur adjacent to external attachments.

Causes: Tube damage occurs due to the combination of thermal fatigue and corrosion. Corrosion fatigue is influenced by boiler design, water chemistry, boiler water oxygen content and boiler operation. A combination of these effects leads to the breakdown of the protective magnetite on the ID surface of the boiler tube. The loss of this protective scale exposes tube to corrosion. The locations of attachments and external weldments, such as buckstay attachments, seal

plates and scallop bars, are most susceptible. The problem is most likely to progress during boiler start-up cycles.

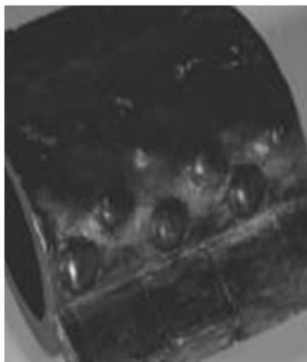
9. Waterwall Fireside Corrosion

Symptoms: External tube metal loss (wastage) leading to thinning and increasing tube strain.

Causes: Corrosion occurs on external surfaces of waterwall tubes when the combustion process produces a reducing atmosphere (substoichiometric). This is common in the lower furnace of process recovery boilers in the pulp and paper industry. For conventional fossil fuel boilers, corrosion in the burner zone usually is associated with coal firing. Boilers having maladjusted burners or operating with staged air zones to control combustion can be more susceptible to larger local regions possessing a reducing atmosphere, resulting in increased corrosion rates.

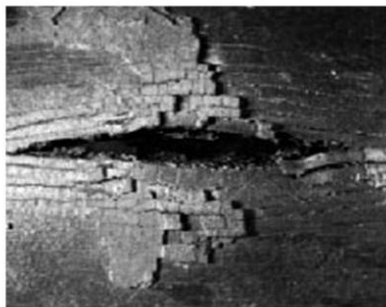
Long-term Overheat

Symptoms: The failed tube has minimal swelling and a longitudinal split that is narrow when compared to short-term overheat. Tube metal often has heavy external scale build-up and secondary cracking.

Causes: Long-term overhear occurs over a period of months or years. Superheater and reheat superheater tubes commonly fail after many years of service, as a result of creep. During normal operation, alloy superheater tubes will experience increasing temperature and strain over the life of the tube until the creep life is expended. Furnace water wall tubes also can fail from long-term overhear. In the case of water wall tubes, the tube temperature increases abnormally, most commonly from waterside problems such as deposits, scale or restricted flow. In the case of either superheater or water wall tubes, eventual failure is by creep rupture.
